HR70-14 Copy 1 (1) 6 Pages February 1965 PHOTOGRAPHIC INTERPRETATION REPORT SOVIET MILITARY ORDER OF BATTLE BALTIC MD APPROVED FOR RELEASE Historical Collection Division HR70-14 DATE: 04-27-2012 WARNING NATIONAL PHOTOGRAPHIC INTERPRETATION CENTER

PROBABLE MILITARY BARRACKS
(57-00N 024-07E)
RIGA, LATVIYSKAYA SSR, USSR
BALTIC MD

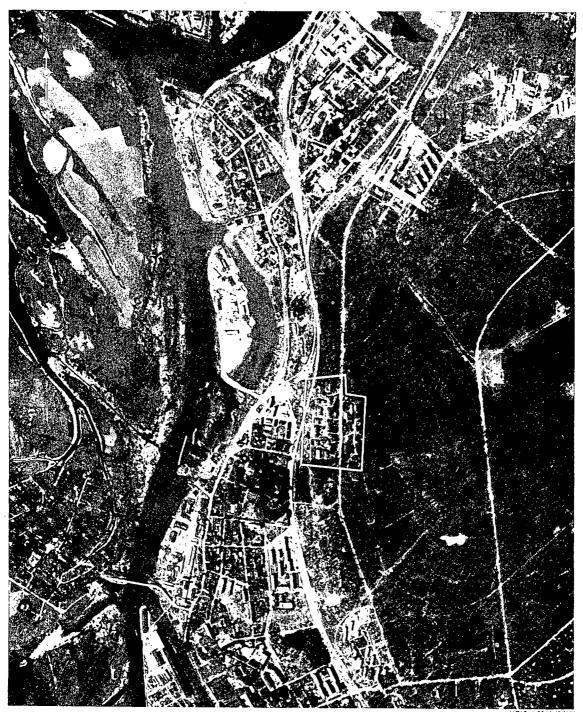
FIGURE 2. PROBABLE MILITARY BARRACKS, RIGA, USSR. JULY 1964.

The installation consists of a barracks and administration area with 6 barracks and 7 other

buildings and a motor pool with 5 buildings (Figures 2 and 3).

Area D contains 6 multistory barracks, 1 multistory administration building, 4 storage buildings, and 2 support buildings.

Area J contains one 110- by 40-foot vehicle storage building, one 120- by 40-foot vehicle storage building, one 125- by 45-foot vehicle maintenance/storage building, one 110- by 45-foot vehicle maintenance/storage building, and 1 administration/support building.

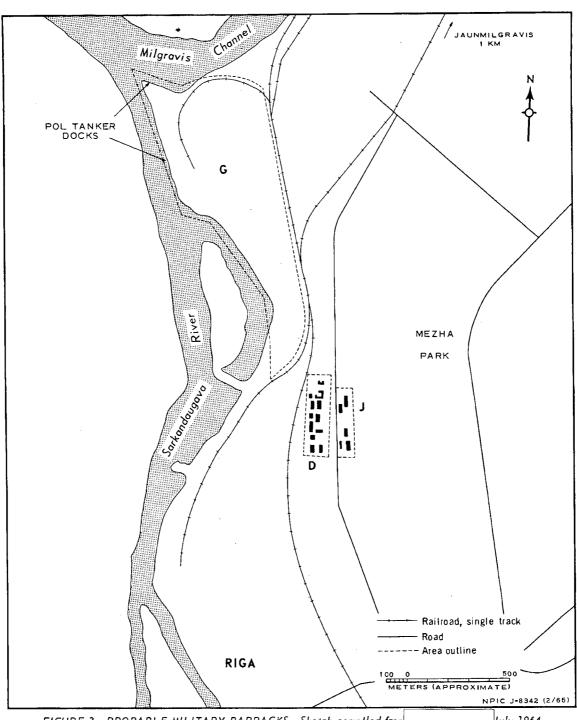
FIGURE 3. PROBABLE MILITARY BARRACKS. Sketch compiled from

A rail line passes the west side of the installation.

A POL refinery and a storage and shipping facility (G) containing approximately 21 POL tanks and 2 oil tanker docks are located 1 kilometer north of this installation.

July 1964.
